FINAL PROJECT REPORT

**Road-Stream Crossing Assessments in the  
Upper White River Watershed**

White River Watershed Partnership, Grantee  
Dr. Thomas Tissue, P.I.

28 October 2017

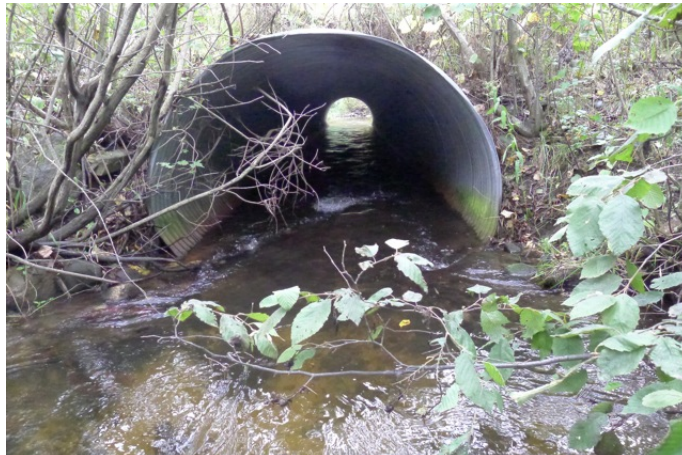
Photo WRWP#24A

The **environmental benefits** of the project included the identification of substandard RSX that are priorities for remediation because they pose barriers to organism passage and/or because they conduce to excessive sediment input. Of the 50 RSX assessed, eight (16%) pose severe barriers to organism passage because the outlets are perched and/or discharge onto shallow cascades formed by rip-rap or aprons (see Photo WRWP#29B). Organism passage is blocked at one site by a curtain-wall weir (see Photo WRWP#9C). At six sites (12%), some combination of shallow water, lack of substrate in the structure, or excessive current velocity leads to varying degrees of interference with organism passage (see Photo #24A).

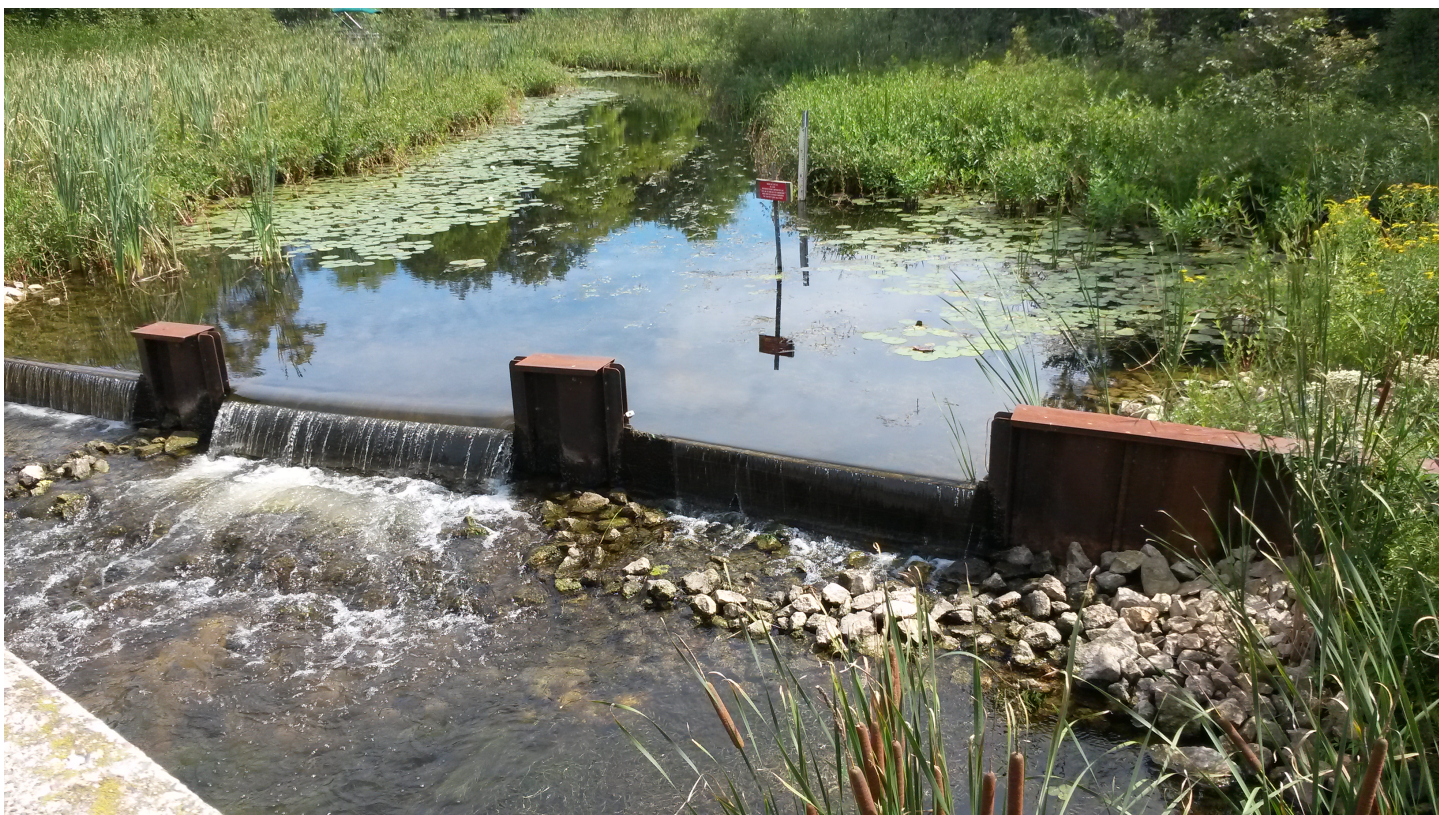
Photo WRWP#9C

9	Robinson Creek x Echo Dr.	Curtain wall weir	“	3.3	Mixed	16.5
13	Rattlesnake Creek x W. Baseline Rd.	No substrate in structure	“	0.4	“	1.6

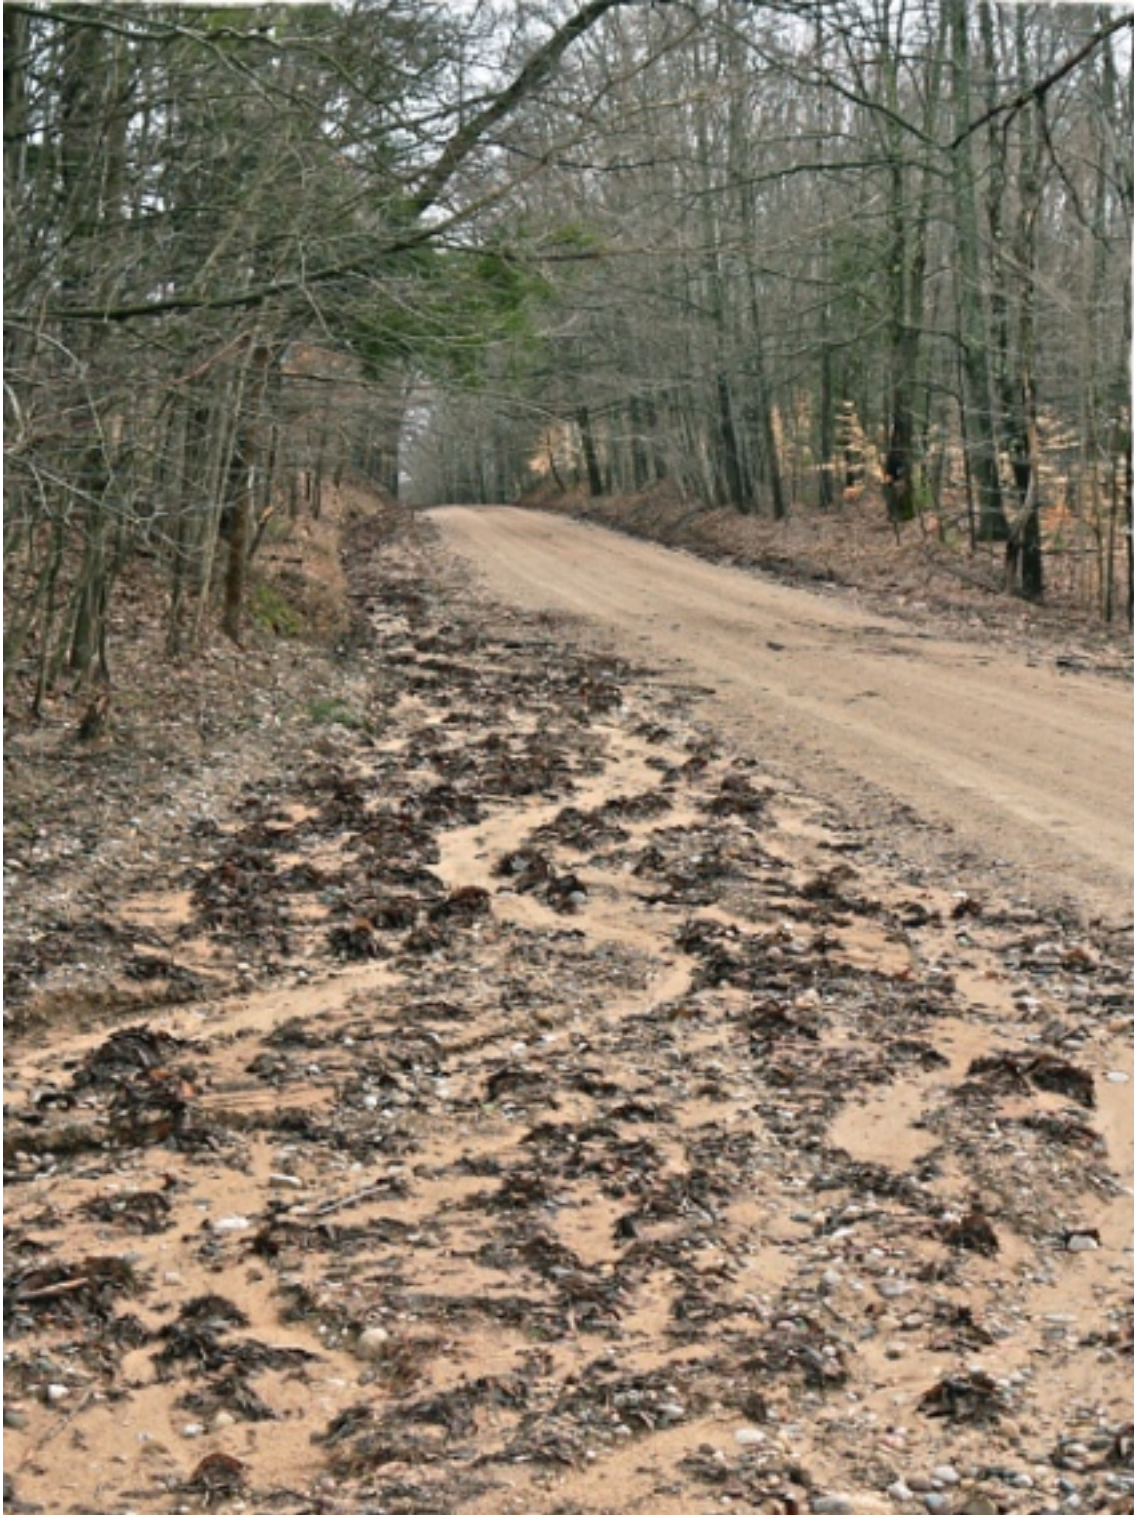
Photo WRWP#35 erosion

35	N. Branch White River x 176 <sup>th</sup> Ave.	Both > 800 ft approaches subject to heavy erosion due soil type and steep slope; diversions not well designed or maintained and only partially effective; approaches need to be paved	Moderate/severe
49	Five Mile Creek x N. Pine Rd.	Left approach (~700 ft) is eroding and needs to be paved, but not all eroded material reaches stream	Moderat
