2019 Data Report for

Herendeene Lake, Benzie County

Site ID: 100139

Herendeene Lake, Benzie County 2019 CLMP Results

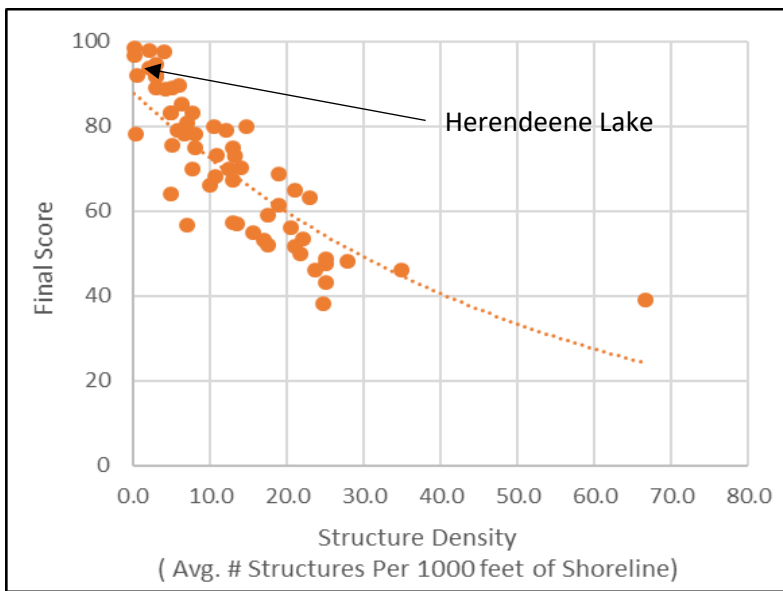
How does your lake compare to others in the program?

Herendeene Lake:	
Number of Sections:	6
Number of Structures:	17
Structure Density:	3
Final Score:	92

All 62 Participating Lakes from 2015-2019:	
Avg. Number of Sections:	16
Avg. Number of Structures:	228
Avg. Structure Density:	12.6
Avg. Final Score:	71

Overall, the lakeshore habitat of Herendeene Lake is doing well and scored higher than average when compared to other lakes in the program. All of the 1000 foot sections scored Good.

The littoral zone was the weak point in Herendeene Lake's habitat (scoring an average of 82). A score of 82 is honestly very good already, but if residents want to improve the overall shoreline quality, this is the component to concentrate on. To improve the littoral zone score, leave woody debris in place and allow native aquatic vegetation to grow in the shallow waters.

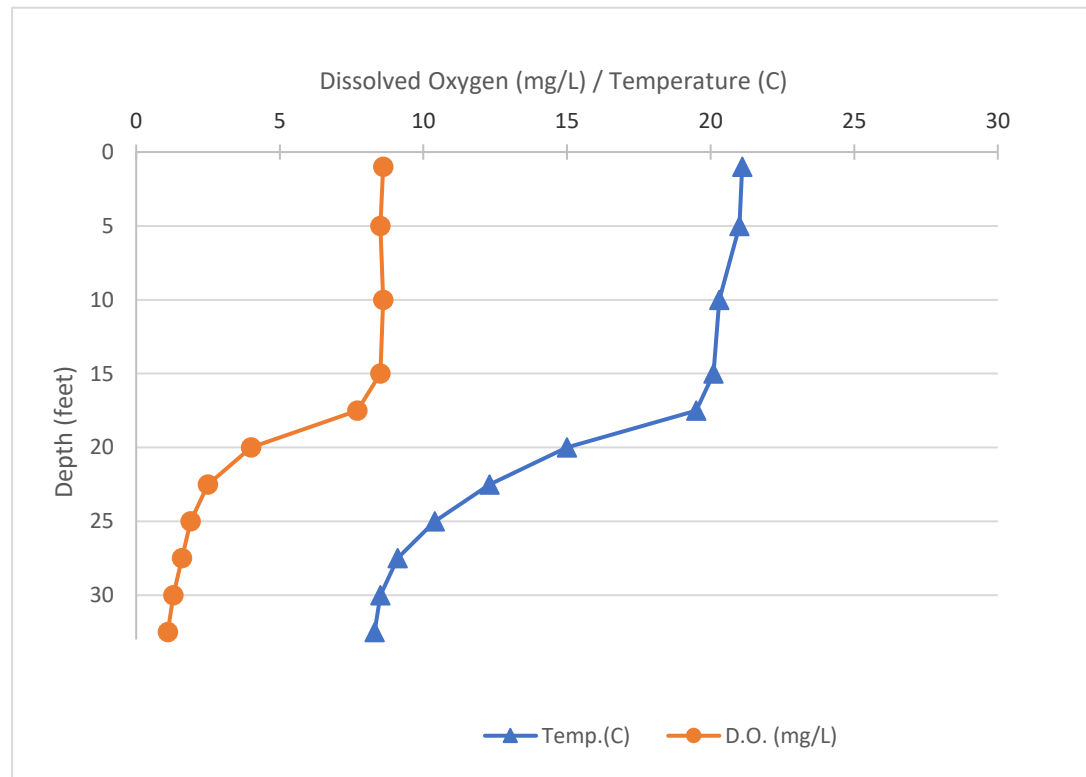
Name: Herendeene Lake
 County: Benzie
 Site ID: 100139
 Date: 9/5/2019

Depth (ft)	Temp.(C)	D.O. (mg/L)
1	21.1	8.6
5	21	8.5
10	20.3	8.6
15	20.1	8.5
17.5	19.5	7.7
20	15	4
22.5	12.3	2.5
25	10.4	1.9
27.5	9.1	1.6
30	8.5	1.3
32.5	8.3	1.1
