2023 Data Report for

Bass Lake, Marquette County

Bass Lake, Marquette County 2023 CLMP Results

Bass Lake Lake, Marquette County 2023 Score the Shore Results

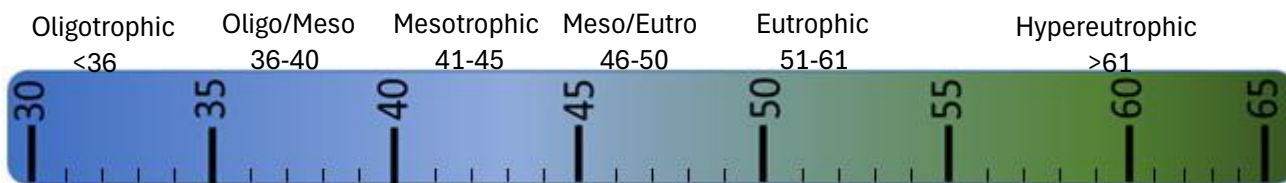
^ Secchi Disk

With a TSI score of 41 based on 2023 Secchi transparency, this lake is rated as mesotrophic.

TSI for Bass Lake in 2023	
Average	41
Secchi Disk	41
Summer TP	
Chlorophyll-a

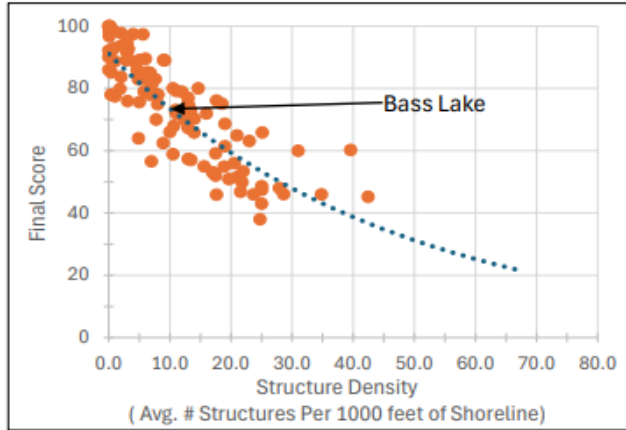
How does your lake compare to others in the program?

Note about graph to the left: The dotted line sets your average expectation of the score of your lake. If your lake is lower than the dotted line, then your shoreline health is lower than average compared to lakes with similar amount of shoreline development. And vice-versa in regards to a lake above the dotted line.

Overall, the lakeshore habitat of Bass Lake scored about average when compared to other lakes in the program with similar amount of development. Most of the 1000 foot sections scored either Fair or Good (16 fair and 17 good), while two sections scored Poor. The results are very similar to last year. The slight differences in the breakdown of the sections are just a matter of a few points-- a different choice made in one or two questions.

The littoral zone was the overall weak point in Bass Lake's habitat (scoring an average of 66). For residents who want to improve the overall shoreline quality, this is the component to concentrate on. Leave woody debris in place, or introduce it specially, and allow native aquatic vegetation to grow in the shallow waters. You can get plenty of ideas for improving shoreline health from the Michigan Natural Shoreline Partnership <https://www.shorelinepartnership.org/>.
