# 2024 Data Report for Lake Christiana, Cass County

Site ID: 140055

# Lake Christiana, Cass County 2024 CLMP Results

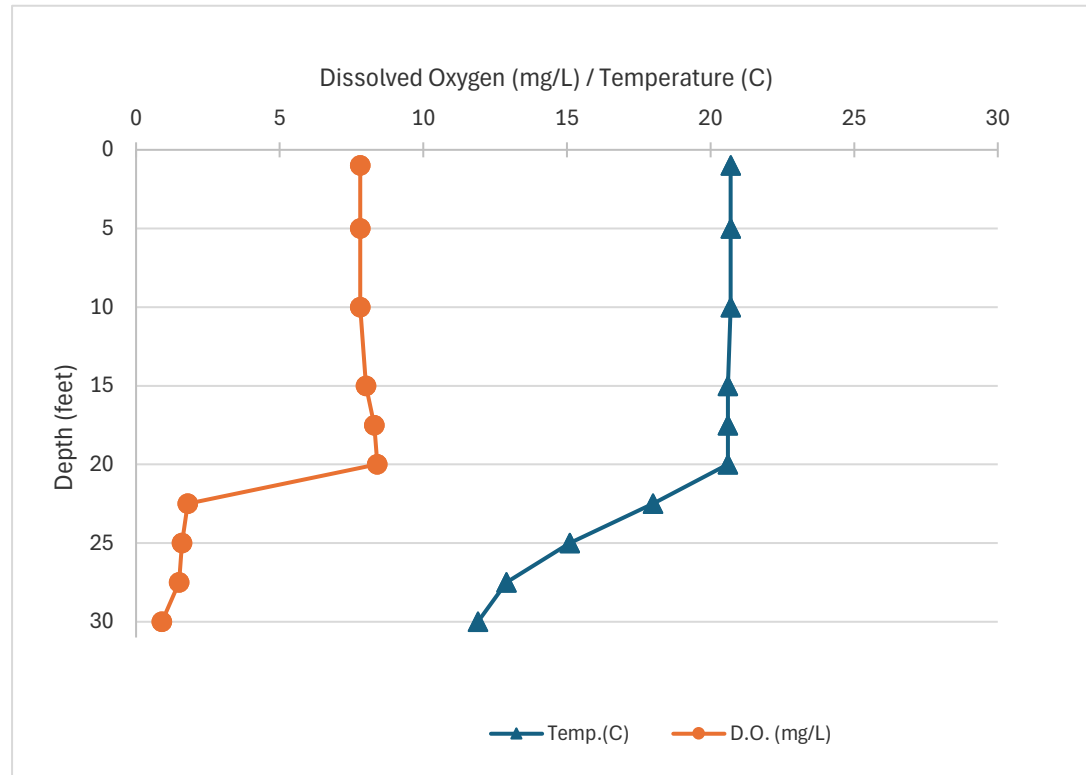
Name: Lake Christiana  
 County: Cass  
 Site ID: 140055  
 Date: 9/24/2022

### Dissolved Oxygen and Temperature Profile

| Depth (ft) | Temp.(C) | D.O. (mg/L) |
