# 2024 Data Report for

# Lake Mecosta, Mecosta County

Site ID: 540057

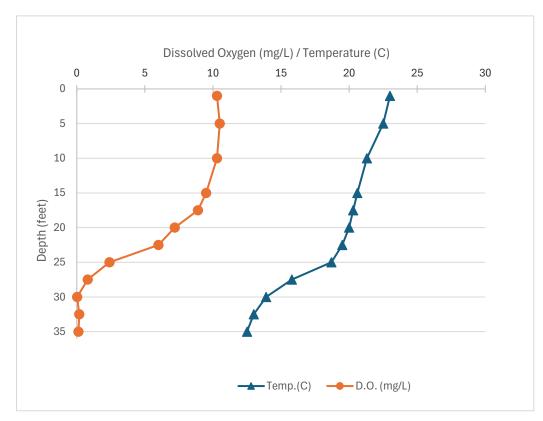
County: Mecosta Site ID: 540057 Date: 9/15/2024

Depth (ft)	Temp.(C)	D.O. (mg/L)
1	23	10.3
5	22.5	10.5
10	21.3	10.3
15	20.6	9.5
17.5	20.3	8.9
20	20	7.2
22.5	19.5	6
25	18.7	2.4
27.5	15.8	0.8
30	13.9	0.03
32.5	13	0.18
35	12.5	0.12
