2024 Data Report for Chippewa Lake, Mecosta County

Site ID: 540050

About this report:

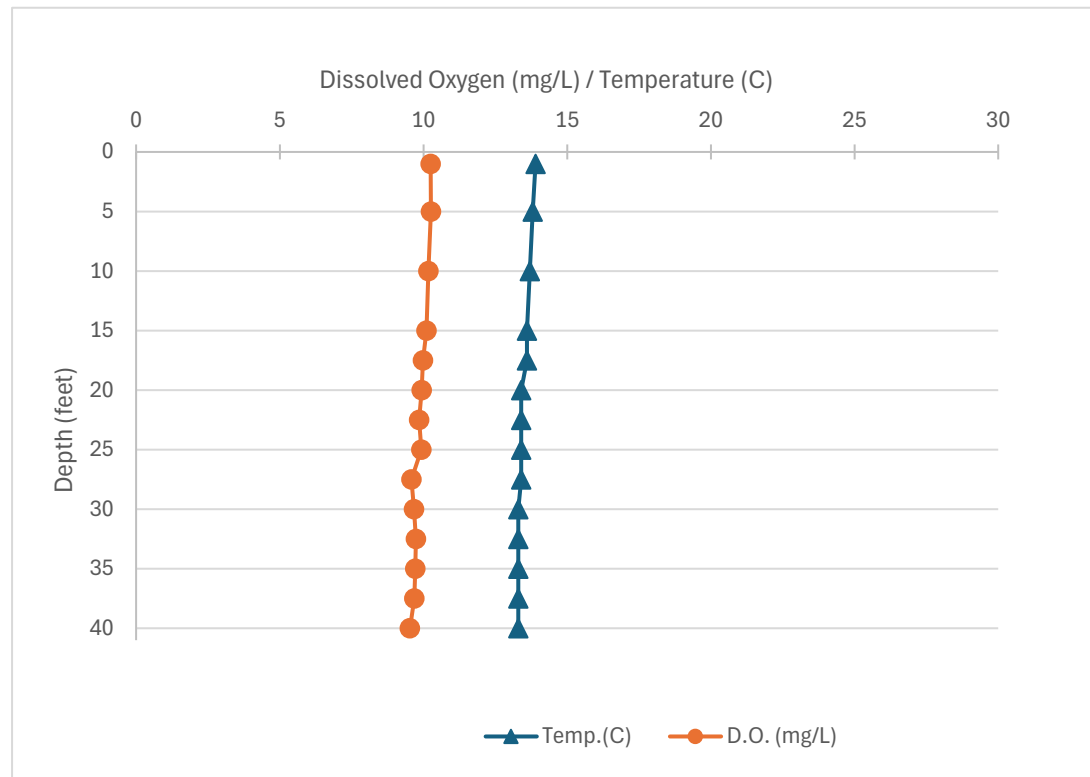
5/2/2024

Dissolved Oxygen and Temperature Profile

Depth (ft)	Temp.(C)	D.O. (mg/L)
1	13.9	10.25
5	13.8	10.26
10	13.7	10.17
15	13.6	10.11
17.5	13.6	9.98
20	13.4	9.94
22.5	13.4	9.85
25	13.4	9.93
27.5	13.4	9.58
30	13.3	9.67
32.5	13.3	9.74
35	13.3	9.72
37.5	13.3	9.68
40	13.3	9.53

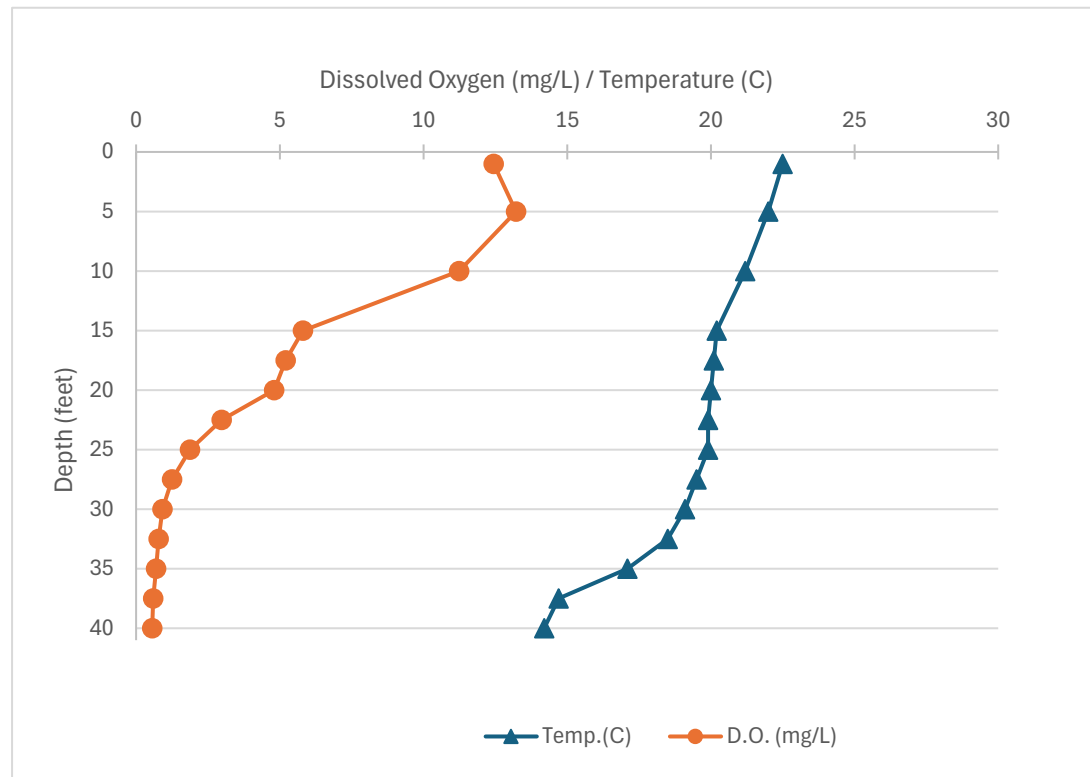
9/18/2024

Dissolved Oxygen and Temperature Profile

Depth (ft)	Temp.(C)	D.O. (mg/L)
1	22.5	12.44
5	22	13.22
10	21.2	11.24
15	20.2	5.81
17.5	20.1	5.2
20	20	4.8
22.5	19.9	2.98
25	19.9	1.88
27.5	19.5	1.25
30	19.1	0.92
32.5	18.5	0.78
35	17.1	0.69
37.5	14.7	0.6
40	14.2	0.56
