# 2018 Data Report for

# Dorner Lake, Manistee County

Site ID: 510272

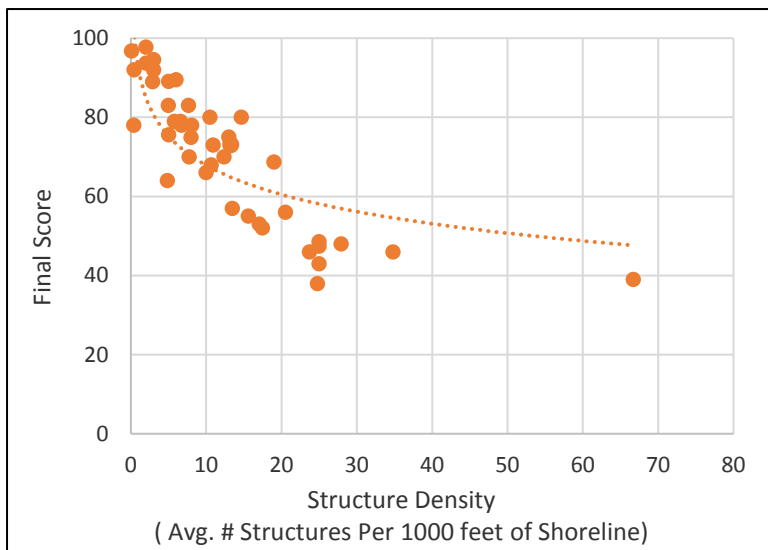
### How does your lake compare to others in the program?

<b>Dorner Lake:</b>	
Number of Sections:	6
Number of Structures:	35
Structure Density:	5.8
Final Score:	90

<b>All 42 Participating Lakes from 2015-2018:</b>	
Avg. Number of Sections:	16.3
Avg. Number of Structures:	248.5
Avg. Structure Density:	15.2
Avg. Final Score:	70.5

There is a very tight relationship between Final Score and Structure Density. It will be interesting to see if and how this changes as more lakes go through this scoring process.

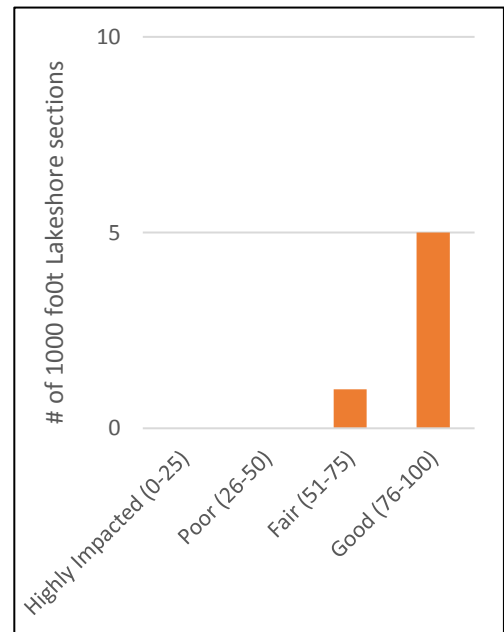
Overall, the lakeshore habitat of Dorner Lake is doing well and scored higher than average when compared to other lakes in the program. All of the 1000 foot sections scored either Fair or Good: 1 fair, and 5 good.

All three of the scoring categories came out approximately the same on Dorner Lake (Average scores: Littoral 89, Riparian 85, Erosion Control 95) This means that there is no particular strength or weakness to the habitat on Dorner Lake.

To improve the score, the section to focus effort on would be section 5, which was the one "fair" section. The riparian score for this section was 55. Reduce the amount of mowed grass and increase the amount of unmowed native vegetation along the lakeshore to boost this aspect of the shoreline habitat.
