**2023 Data Report  
for  
Swan Lake, Allegan County**

Site ID: 030261

# Swan Lake, Allegan County 2023 CLMP Results

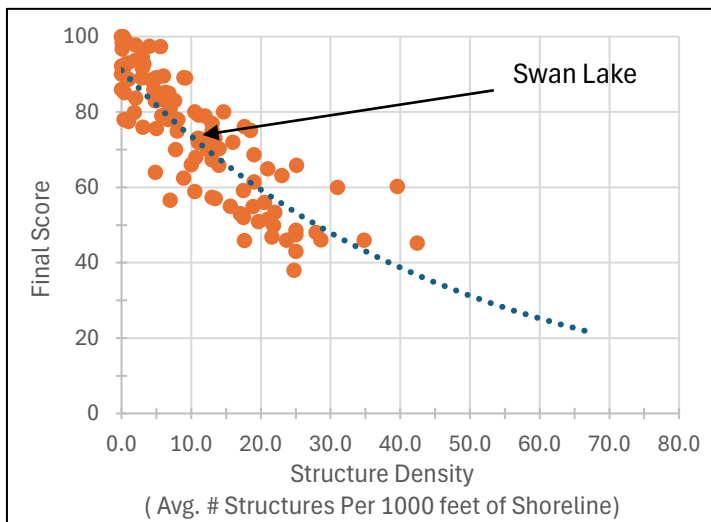
Swan Lake Lake	
Number of Sections:	9
Number of Structures:	147
Structure Density:	16
Final Score:	72

All 106 Participating Lakes from 2015-2023:	
Avg. Number of Sections:	16
Avg. Number of Structures:	223
Avg. Structure Density:	12
Avg. Final Score:	73

Note about graph to the left: The dotted line sets your average expectation of the score of your lake. If your lake is lower than the dotted line, then your shoreline health is lower than average compared to lakes with similar amount of shoreline development. And vice-versa in regards to a lake above the dotted line.

Overall, the lakeshore habitat of Swan Lake scored about average when compared to other lakes in the program with similar amount of development. Most of the 1000 foot sections scored either Fair or Good (5 fair and 3 good), while one sections scored Poor.

The riparian zone was the weak point in Swan Lakes score (scoring an average of 58, and the Poor section only scored a 9). Reduce the amount of mowed grass and increase the amount of unmowed native vegetation along the lakeshore to boost this aspect of the shoreline habitat. You can get plenty of ideas for improving shoreline health from the Michigan Natural Shoreline Partnership. <https://www.shorelinepartnership.org/>
