2024 Data Report for Juno Lake, Cass County

Site ID: 140058

Juno Lake, Cass County 2024 CLMP Results

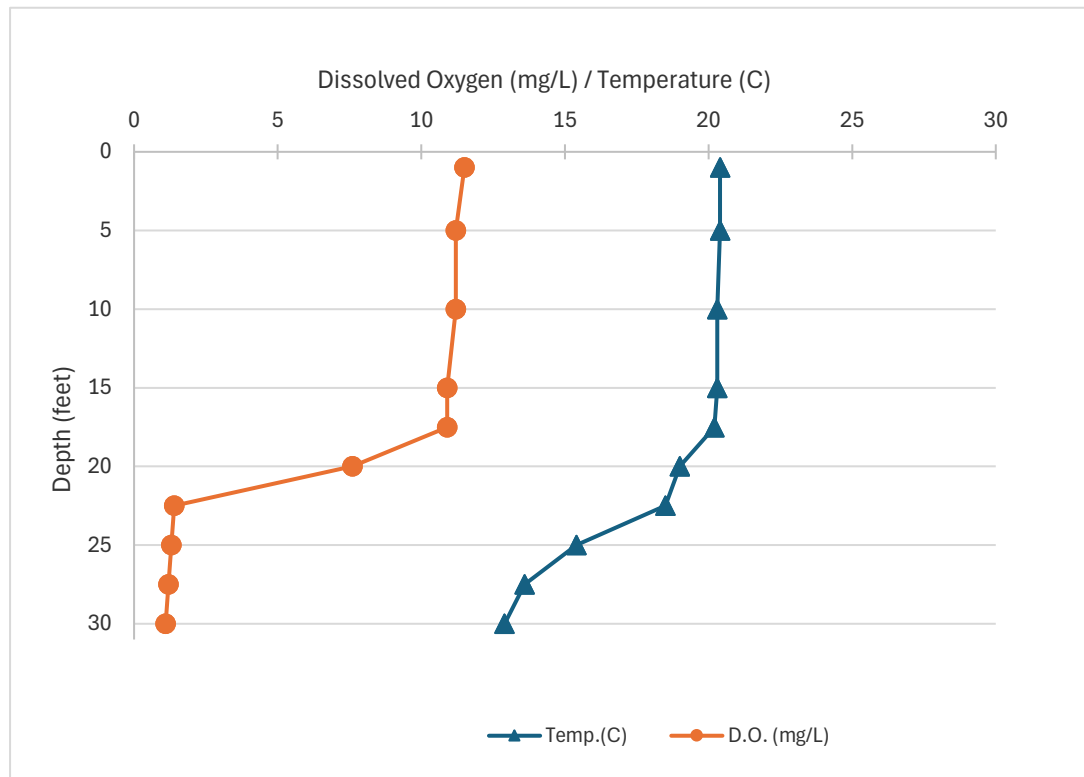
Dissolved Oxygen and Temperature Profile

Name: Juno Lake
 County: Cass
 Site ID: 140058
 Date: 9/24/2022

Depth (ft)	Temp.(C)	D.O. (mg/L)
1	20.4	11.5
1	20.4	11.5
5	20.4	11.2
5	20.4	11.2
10	20.3	11.2
10	20.3	11.2
15	20.3	10.9
15	20.3	10.9
17.5	20.2	10.9
17.5	20.2	10.9
20	19	7.6
20	19	7.6
22.5	18.5	1.4
22.5	18.5	1.4
25	15.4	1.3
25	15.4	1.3
27.5	13.6	1.2
27.5	13.6	1.2
30	12.9	1.1
30	12.9	1.1
