2024 Data Report for Second Fortune Lake, Iron County

Site ID: 360177

Second Fortune Lake, Iron County 2024 CLMP Results

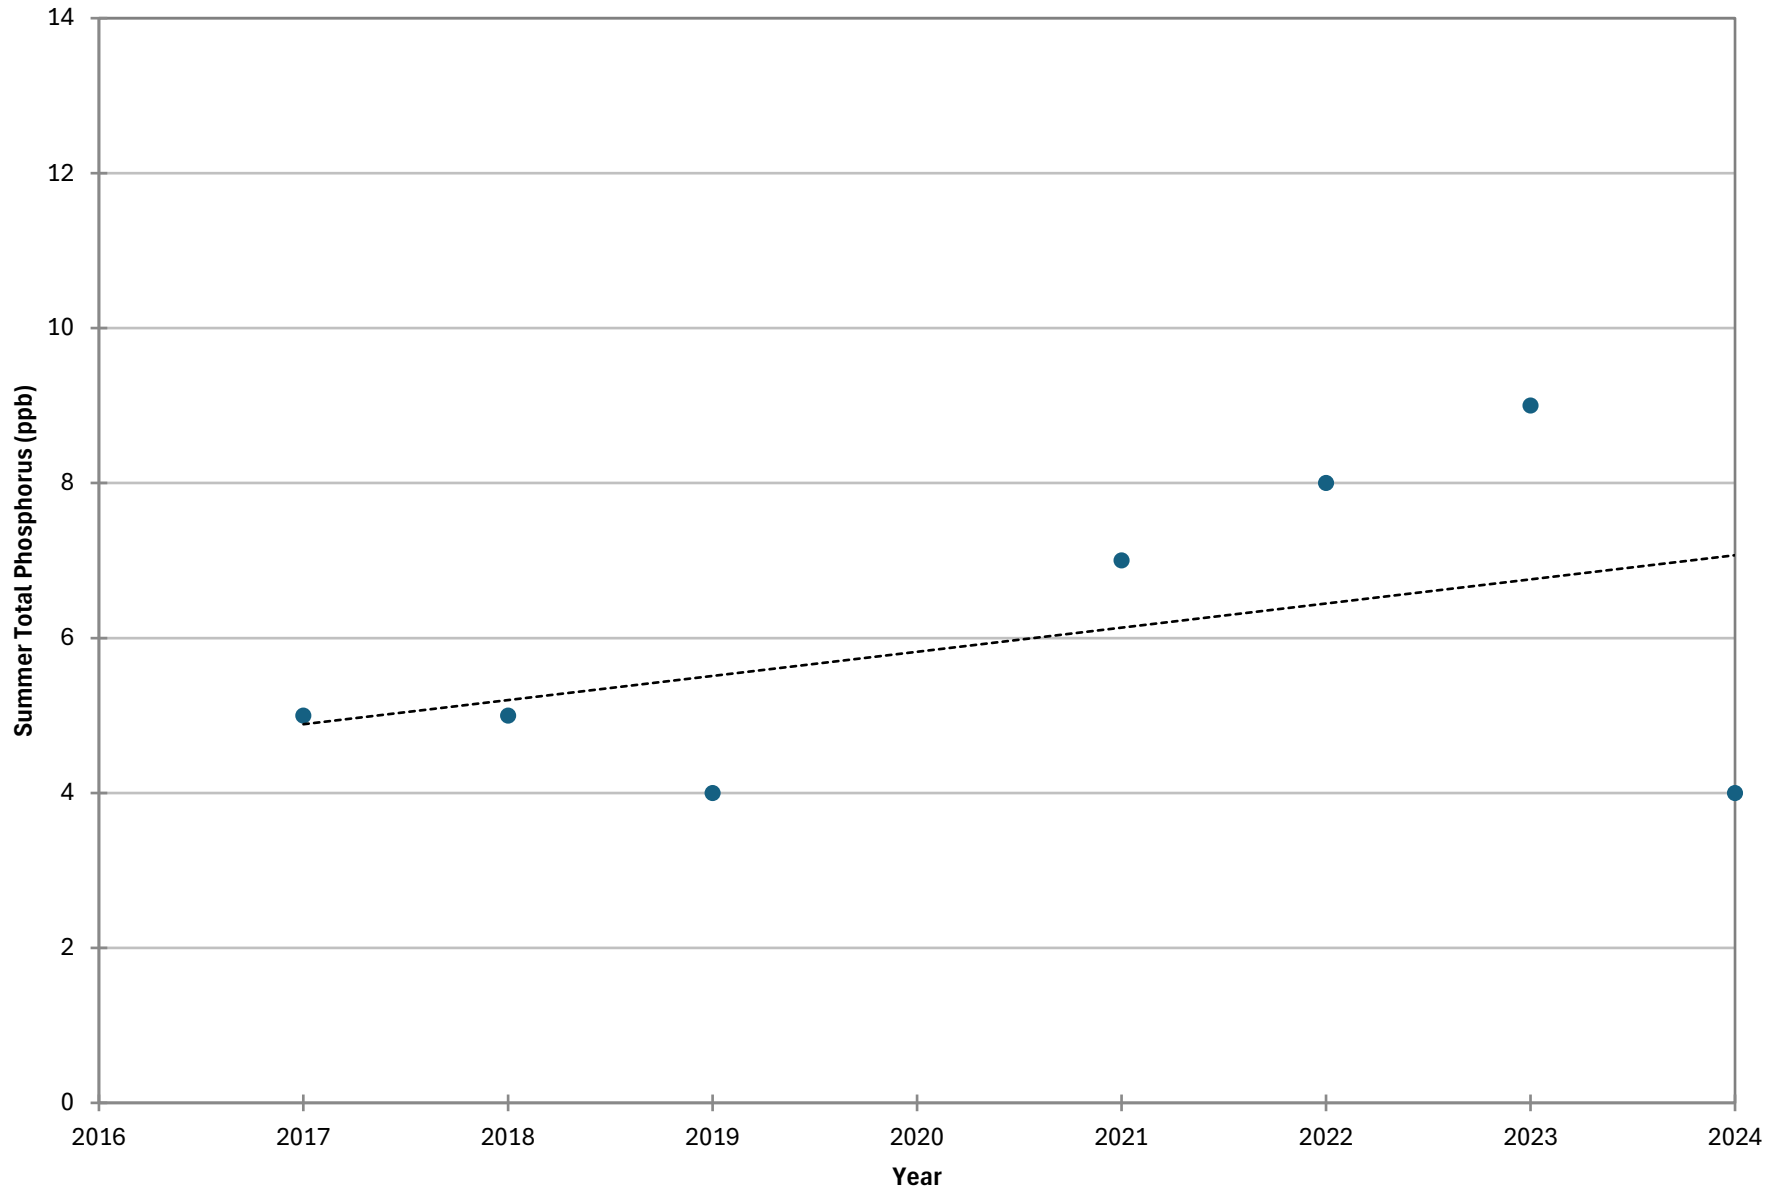
COOPERATIVE LAKES MONITORING PROGRAM
SUMMER TOTAL PHOSPHORUS

Second Fortune Lake (Iron Co.), 360177

Year	# Samples	Min	Max	Average	Std. Dev	Carlson TSI
2024	1	<5 T	<5 T	<5 T	NA	27
2019-2023	4	<5 T	9.0	7.0	2.2	32
2017-2018	2	5.0	5.0	5.0	0.0	27
2024 All CLMP Lakes	200	<= 5	4.0	190.0	14.9	18
