# 2024 Data Report for

## **Scram Lake, Kent County**

Site ID: 410728

## Scram Lake, Kent County 2024 CLMP Results

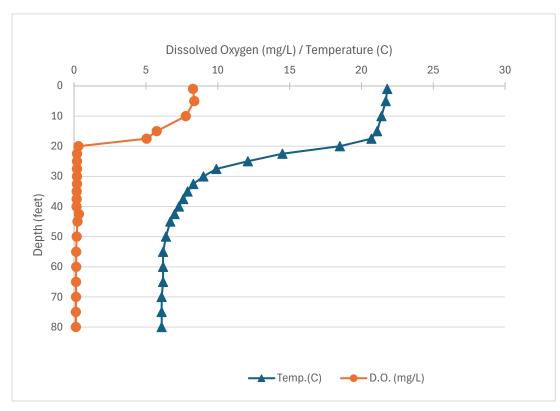
County: Kent Site ID: 410728 Date: 9/12/2024

#### Depth (ft) Temp.(C) D.O. (mg/L) 8.28 21.8 5 21.7 8.37 10 21.4 7.78 15 21.1 5.75 17.5 20.7 5.05 20 18.5 0.31 22.5 14.5 0.21 25 12.1 0.21 27.5 9.9 0.21 30 0.2 9 32.5 8.3 0.2 35 7.9 0.18
